Audio Restoration Project: Repair B&O Bang and Olufsen BeoGram 4000 / 4002 / 4004 / 6000 Tangential Turntable

This article describes how to perform a complete restoration of this model, including taking care of all known failures and defects. The Manufacturer's Service Manual, available from BeoWorld, is an integral component of the proper restoration process.

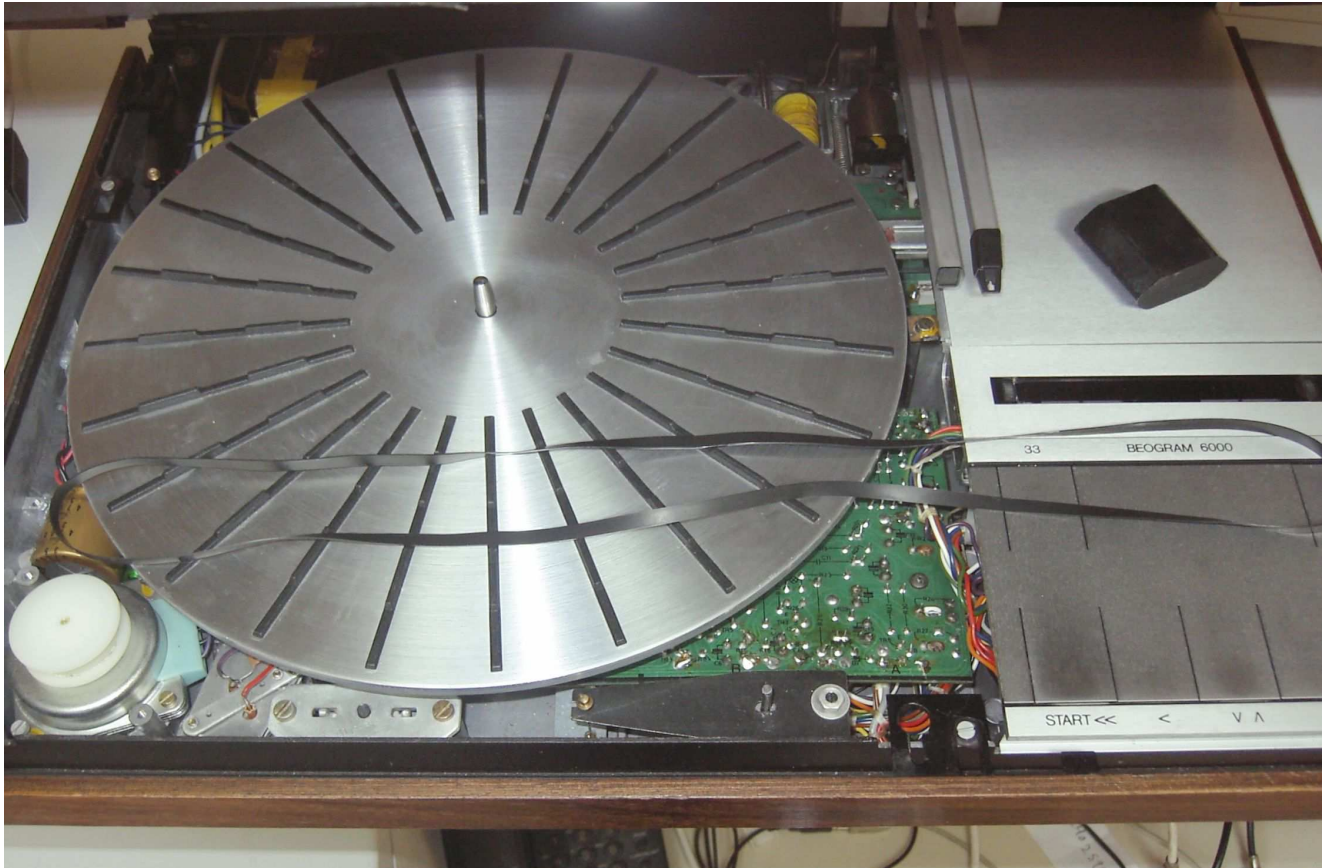
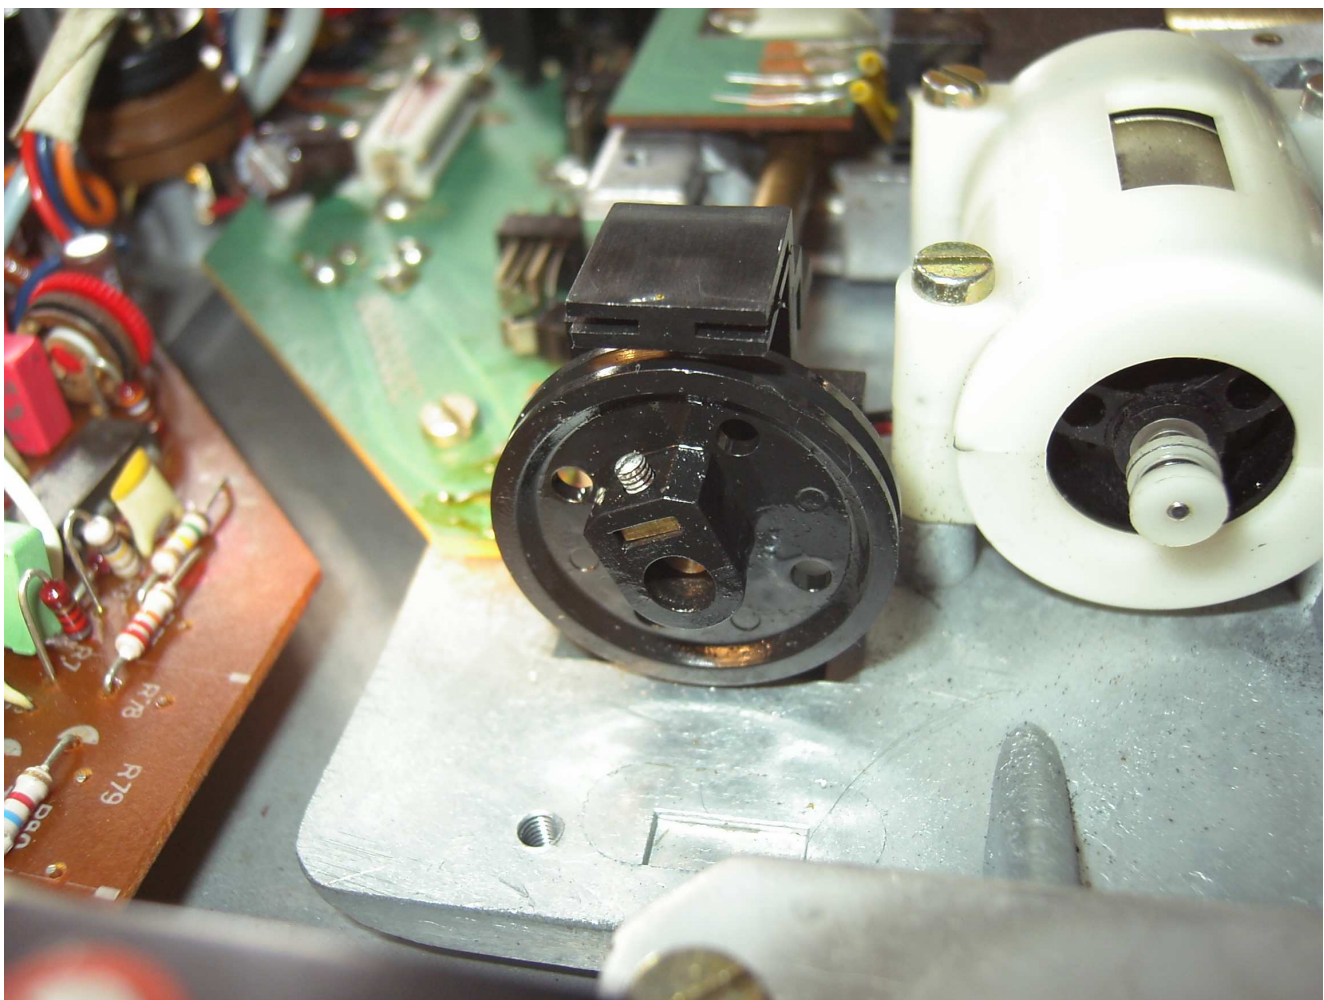
1. Replace the Rubber Drive Belts

When selecting a 45 record, the arm would lower at the 33 LP landing zone, the first-time. The worn out belt was slipping, and the platter didn't reach correct speed in time for the detector circuit to "see" it!

Of course, on the second try, it was already turning, so it would lower correctly at the 45 zone... there's a filter in the detection circuit, and it needs the correct frequency of moving bars under the sensor.

There is also a second smaller belt which moves the tone-arm left and right. This is on the DC motor.

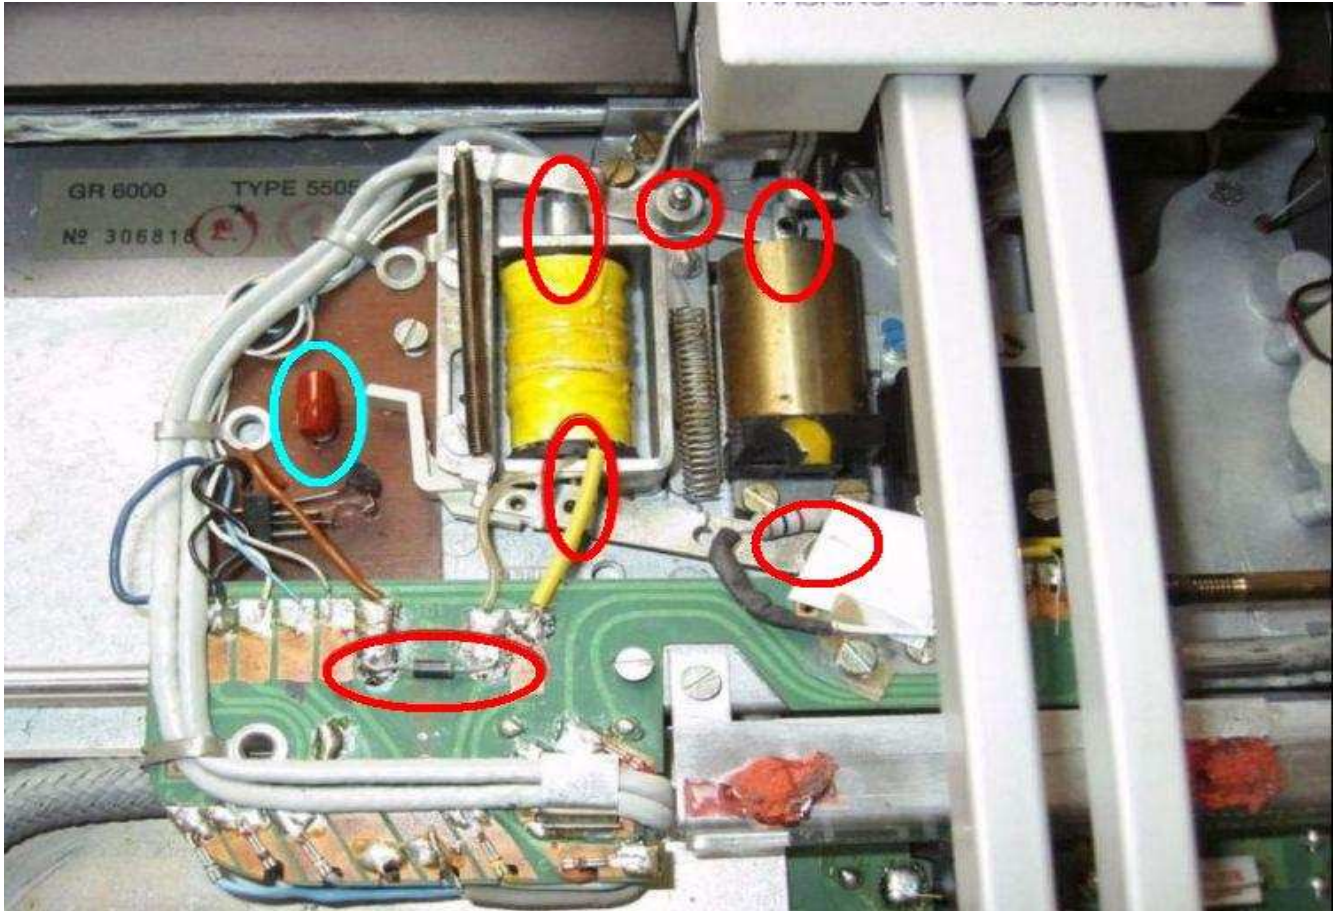
2. Lubrication

If the arm does not lower (barring any severe electrical problem), the cause is dried / coagulated lubricant on the RED circled areas. If you can see any dried grease, remove it.

Then gently squirt Sewing Machine oil onto:

1. Both ends of the Yellow Solenoid Piston (Thick and Thin parts)
2. The Piston of the Copper Damper
3. The Axle pivot connecting the Solenoid and Damper

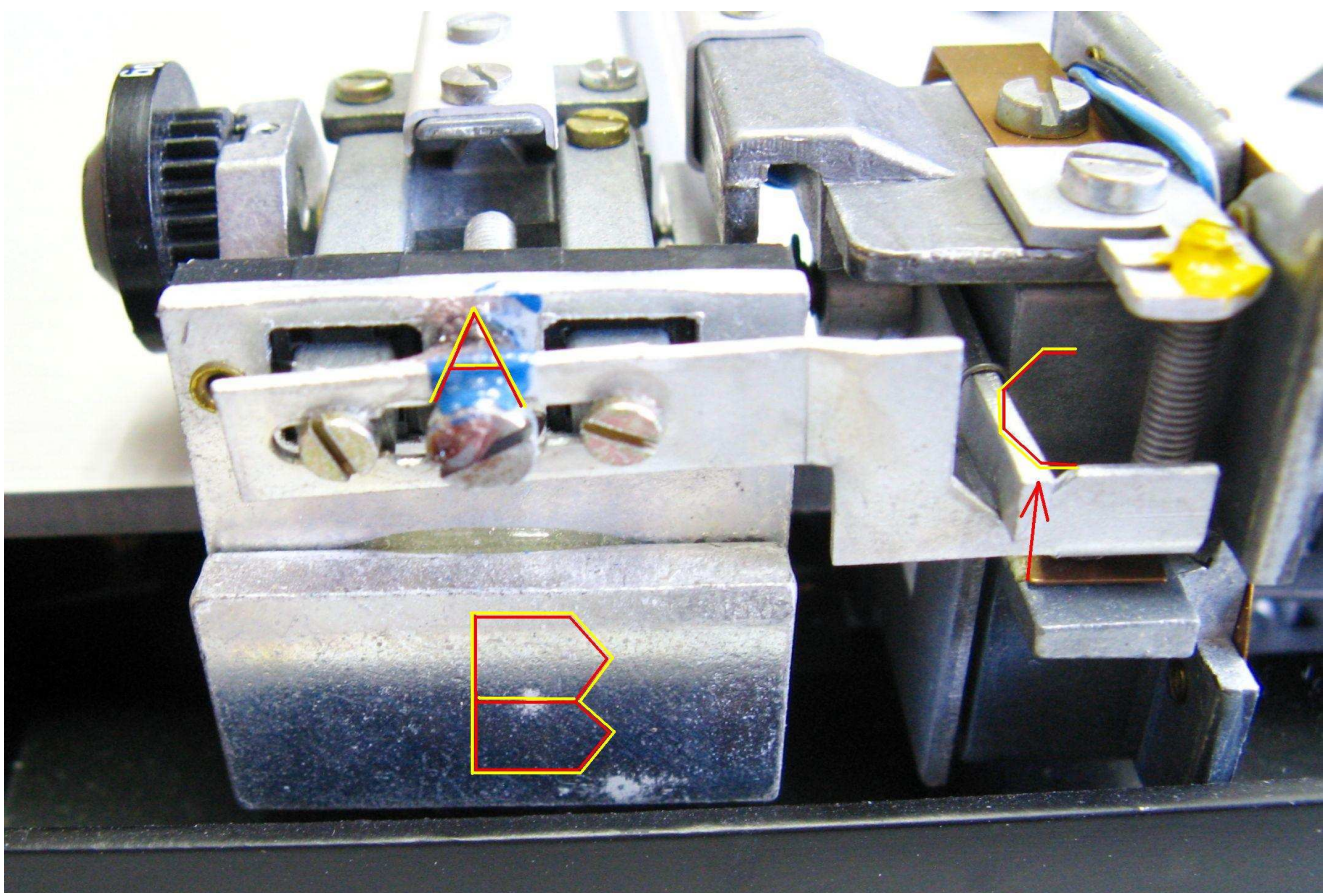
3. Zero-Balancing the Tone-arm

Over time, the bolt (A) holding the tone-arm's counterweight (B) works itself loose, and the tone-arm is no longer in perfect balance. Sound is adversely affected. Leave the cartridge attached to the tone-arm during this procedure.

1. Set the round Tracking-weight wheel to 0 grams.
2. Lift up the spring-loaded arm (C) , and keep holding it up.
3. Tighten or Loosen bolt A (sometimes it may have old lacquer securing it), all the while tapping the tone-arm gently, until you feel that it is in perfect longitudinal balance.
4. Release Arm C, apply new lacquer on bolt A, and rotate the tracking-weight to that appropriate for your cartridge.
5. Other mechanical adjustments need to be made - reference to the Service Manual is recommended.

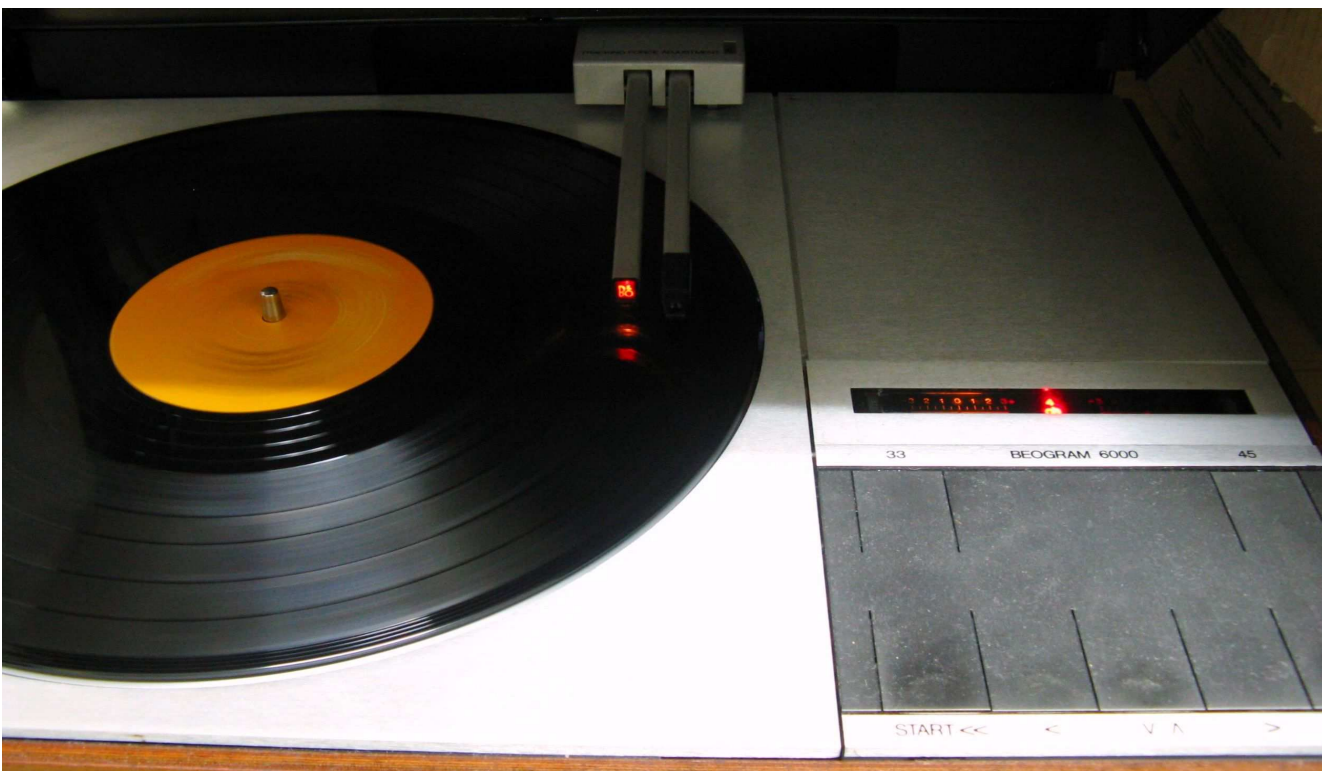
6. 33/45 Speed Problem; PCB 8009024 or 8009033

When pressing START <<, The 33 indicator light (on the left of the red 4ch light), illuminates for a split second, and then immediately, the 45 indicator light illuminates, and remains illuminated (with platter speed 45, as indicated by the light).

This is while the tone arm is still moving to the left slowly over the flat aluminum plate, BEFORE the tone arm even reaches the edge of the platter, let alone the LP.

In short, there was a problem in the 33 circuit, which the previous owner had skillfully hidden by disconnecting the 33 indicator bulb.

When I connected the 33 bulb to the circuit, this above problem appeared.

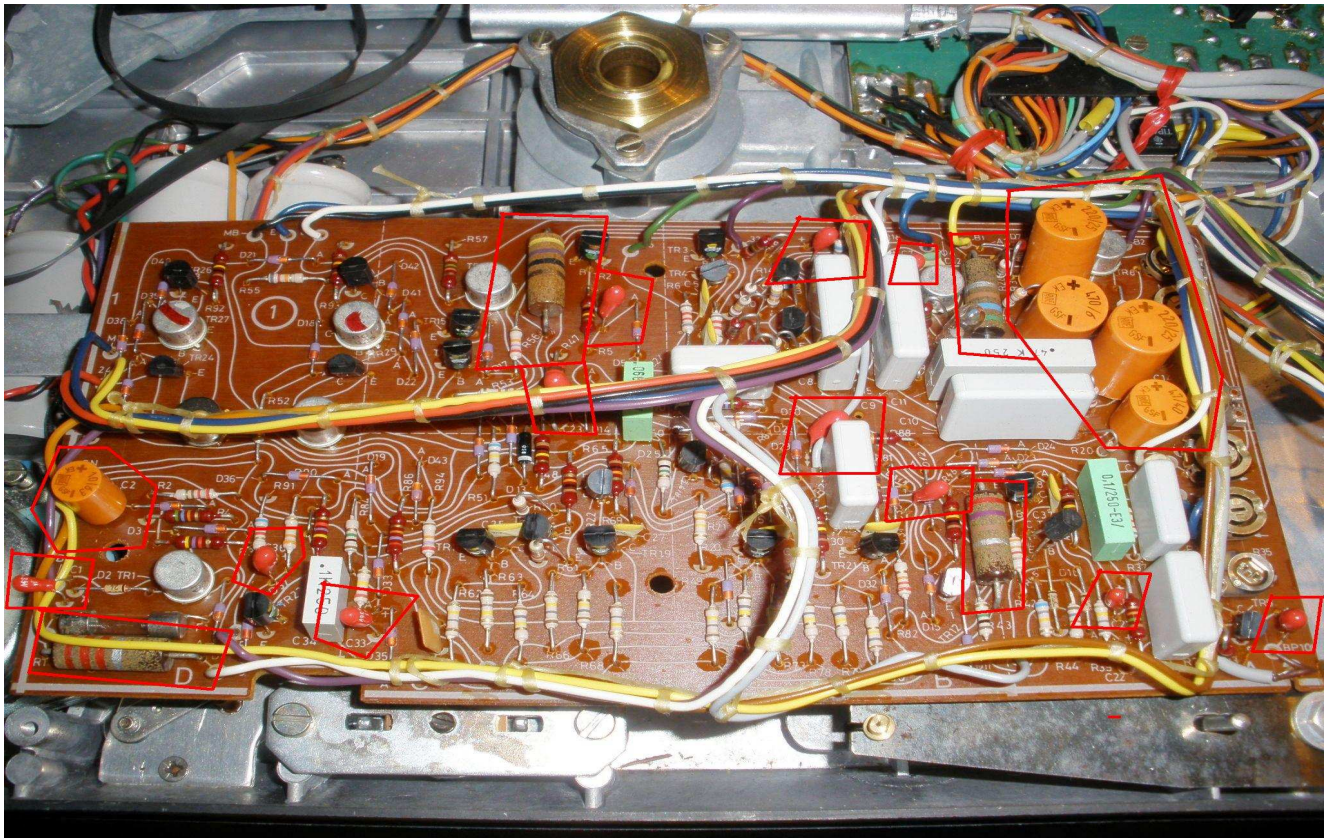
This is the Control PCB before Restoration, showing the components to be replaced

It was repaired by the following:

1. Replacing D6 - 1N4148
2. Replacing C4 and C5 - 3.3nF with Panasonic Polypropylene units
3. Restripping and Resoldering all the coloured wires onto the PCB - many were frayed, and a couple were hanging on by their last strands.
4. Replacing all Electrolytic and Tantalum Capacitors as follows: >10uF with Panasonic FM units, and < 4.7uF with Wima MKS2 and Panasonic Propylene units. Note that some of the Capacitors must be mounted horizontally, to prevent contact with the suspension plate underneath the PCB.
5. The 6 oxidized potentiometers at the right were replaced by Piher PTC10 Cermet units.

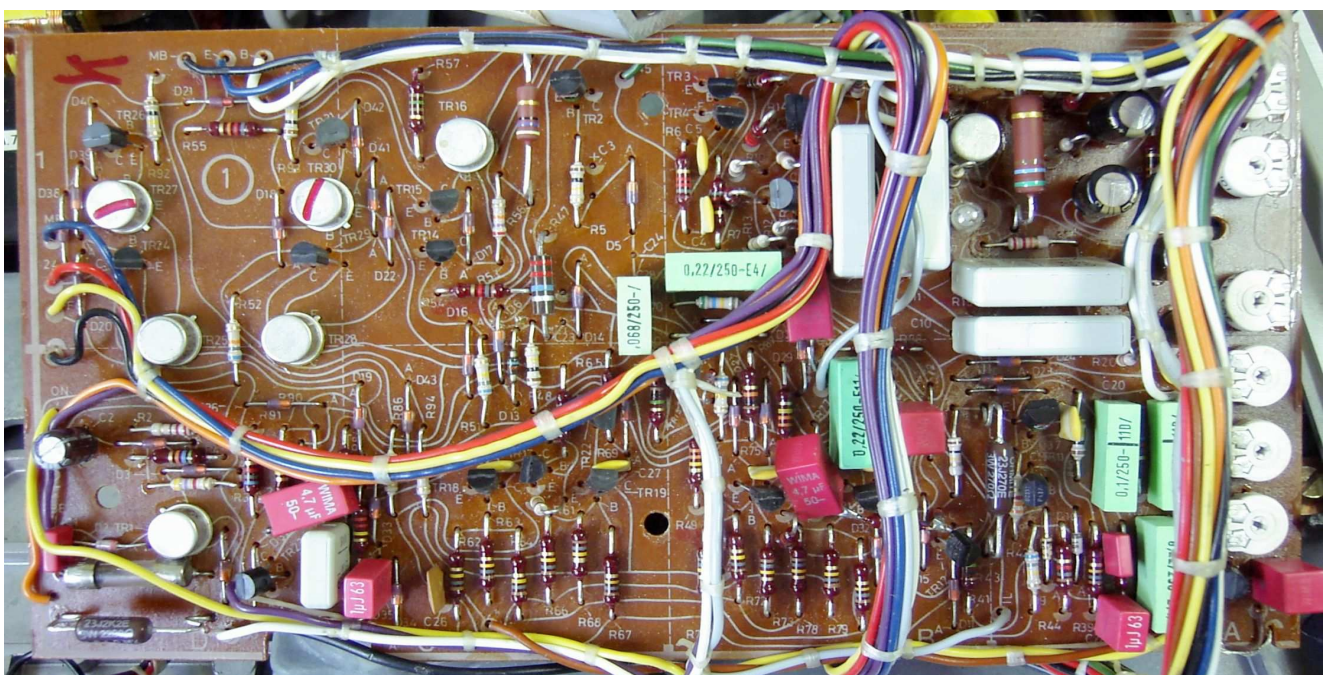
This is the Control PCB after Restoration

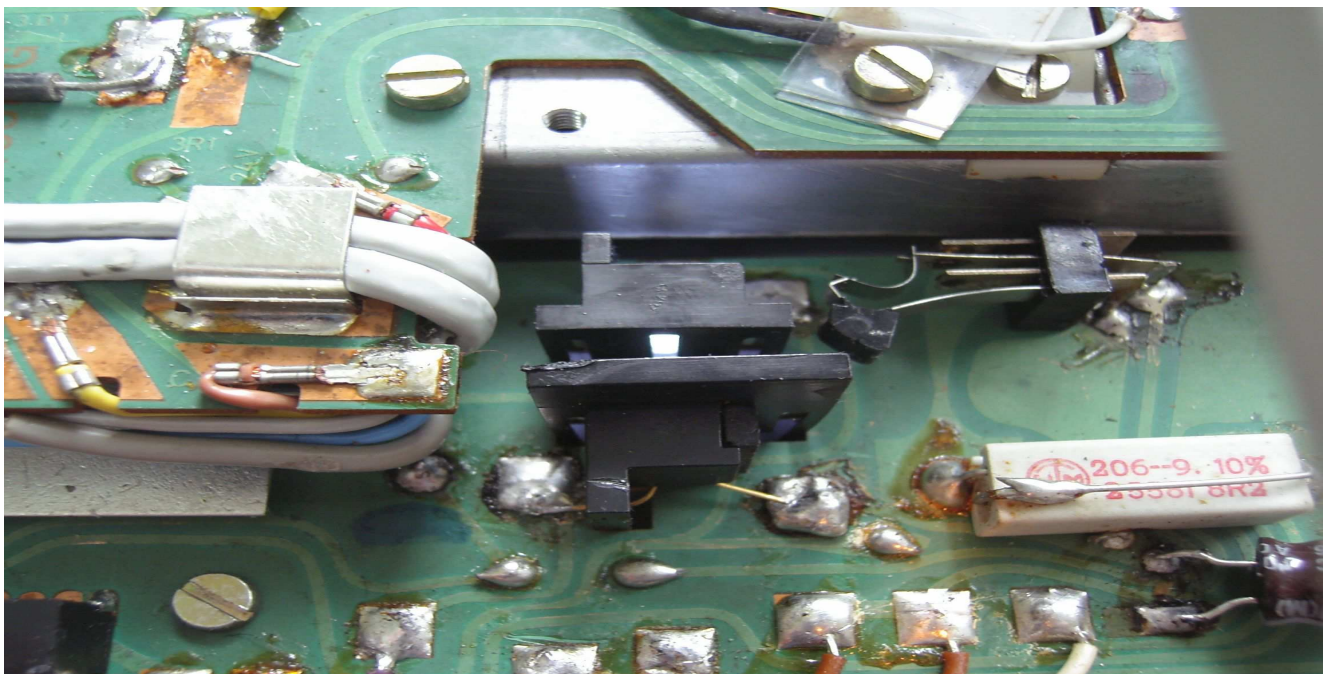
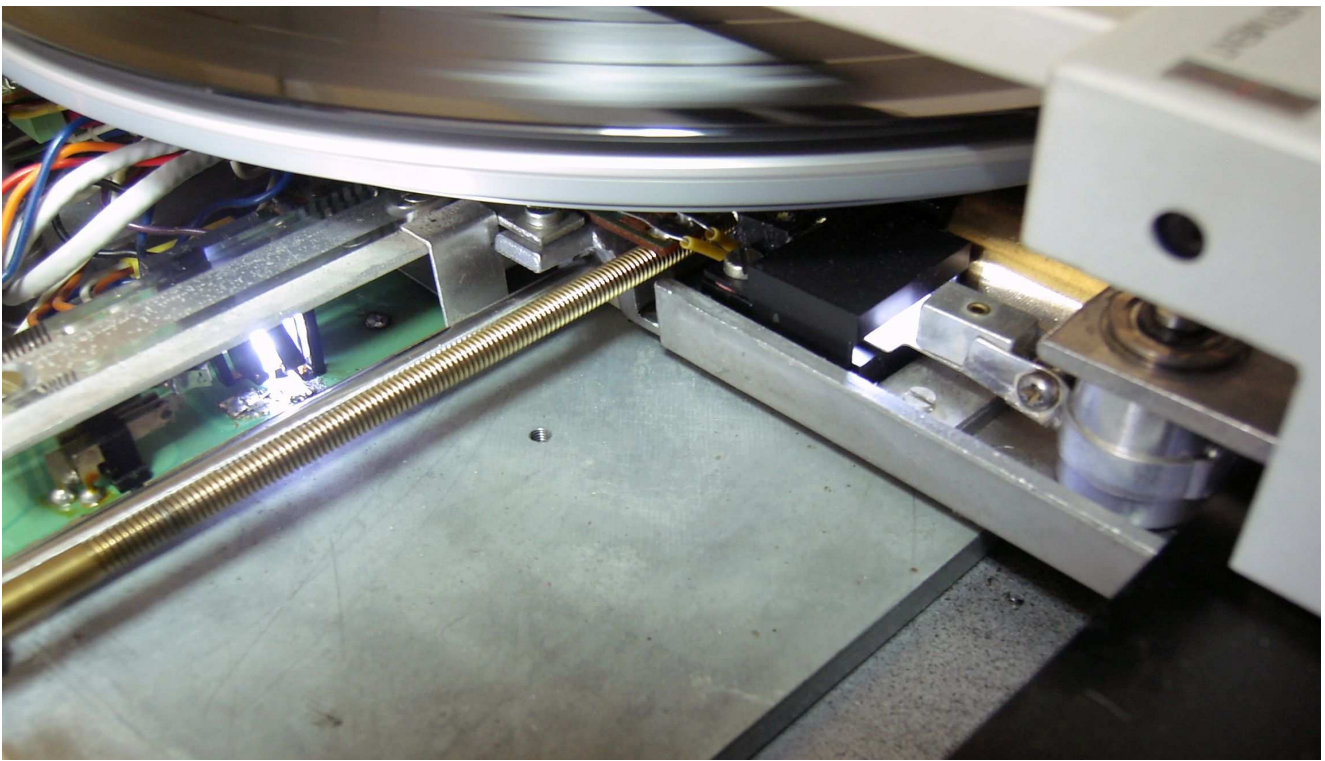
8. PCB 8009032 Modification, LP prematurely ends play

There is an ongoing problem with the Photo-transistor, and having to adjust the incandescent lamp, so that the light reaches the transistor correctly.

I decided to go for overkill - I replaced the 24V 25mA lamp (IL1) with an opaque white medium-intensity 3V LED. This light from this LED is highly directional, and much more intense than the original lamp. So the Photo-transistor, on my unit a Motorola 2N5779, should be able to sense the light more precisely now.

The 82 Ohm resistor (R4) from the Cathode to Ground must also be replaced by a 1Kohm 1W resistor.

Before replacing the clear acrylic ruler with the black stripes, make sure that it is absolutely clean, with no finger- or other marks!

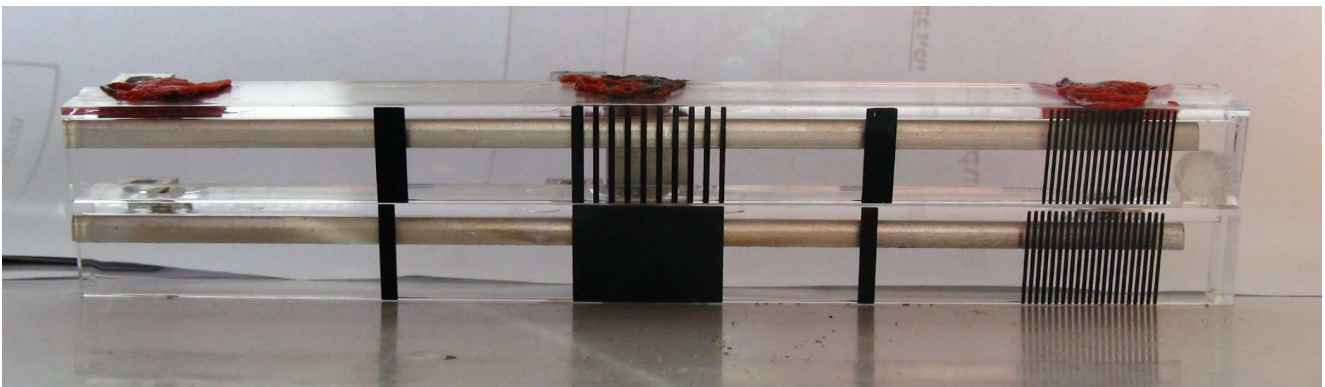
Here are 2 Rulers from the Optical-sensing circuit.

The top one is an early-production unit, and the bottom one is a later-production unit.

The critical difference is at the vertical bars on the right-hand side – this is the End-of-Play signal.

The top one requires the stylus to keep tracking to a later (closer to the centre-hole) position, before signaling "Lift-and-Return".

But if you are playing a later LP, the stylus will never reach that position, so will not "Lift-and-Return"

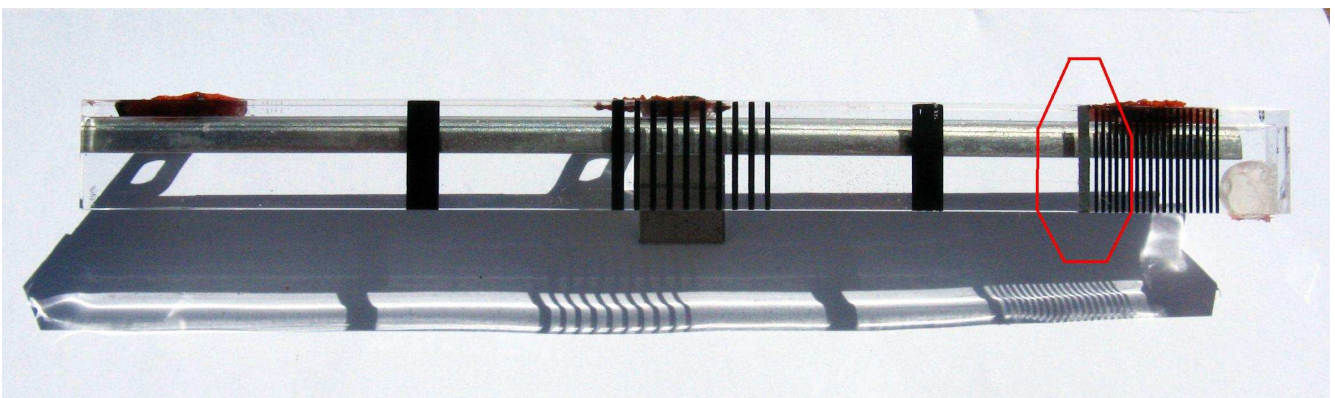
The bolts securing the acrylic ruler to the aluminum mounting bar have been sealed with old-style red sealing wax.

The solution is to add a single wide stripe at that position, as shown below. The stylus will then "Lift-and-Return" correctly.

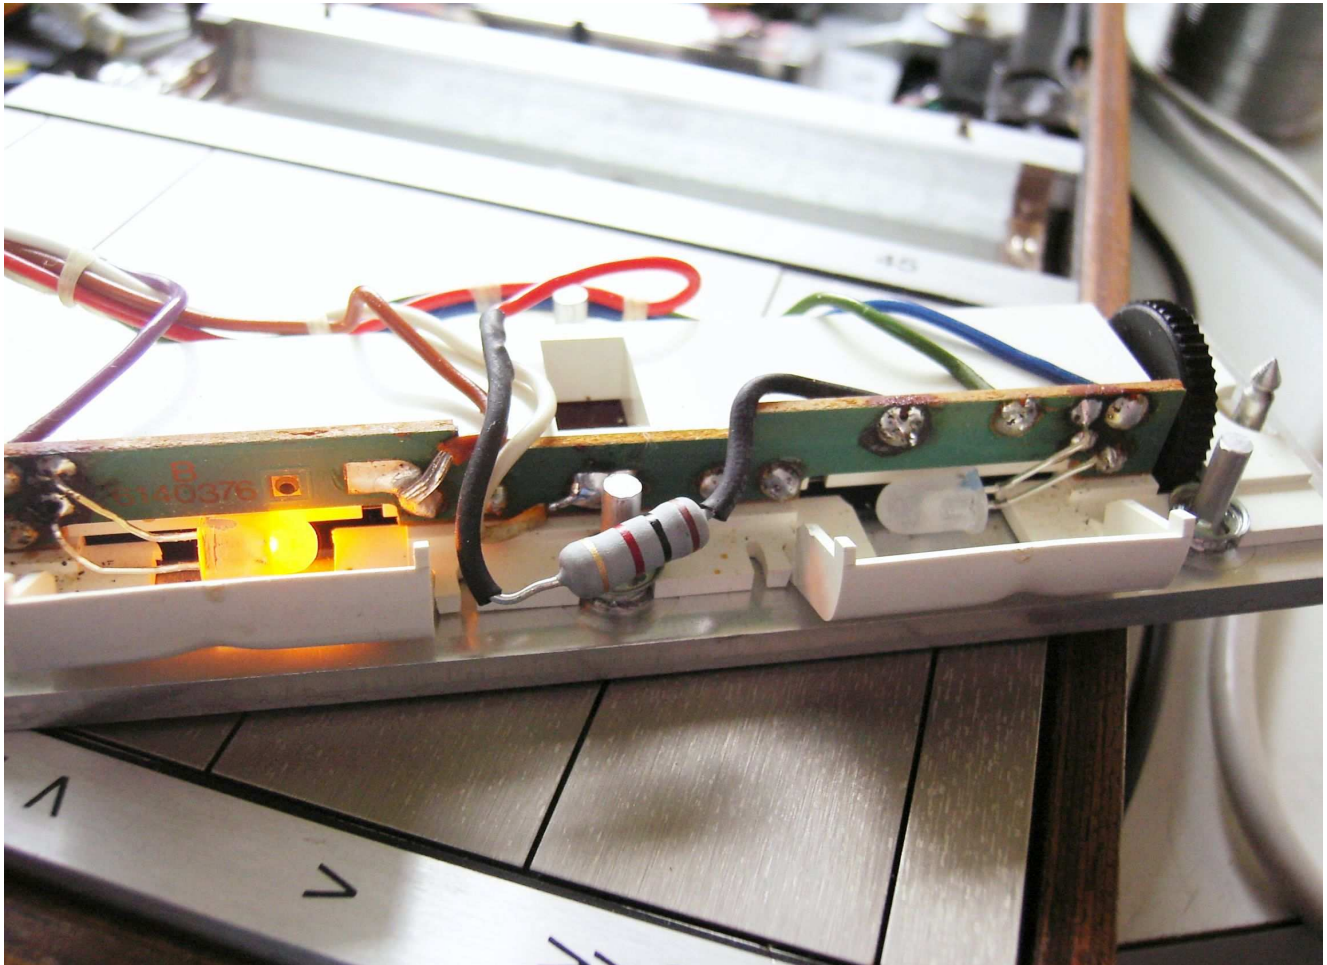
10. 33 / 45 Speed Indicator LED upgrade

The 33 and 45 indicator lamps heat up, and deform their plastic housings.

In the picture, on the white plastic hinged shields, you can see the yellowish damage, due to heat emitted by the standard incandescent lamps.

Current to illuminate the 33/45 Speed lights is supplied by the Red wire.

The voltage present on the Red wire is 22.8VDC positive, which has to be reduced to about 2 Volts.

I unsoldered the Red wire from the PCB, and soldered one end of the resistor in its place.

I soldered the other end of the resistor to the Red wire.

I placed the resistor at a small distance from the white plastic housing (around the metal bolt), to eliminate the possibility of heat damage.

The LED's must be sanded lightly to give an opaque appearance, to distribute the light evenly.

I marked the -ve lead of the LED with a blue marker, which you can see faintly on the upper edge of the LED. If the LED's polarity is incorrect, it will not illuminate.

In the picture, the LED's upper conductor is -ve, and the lower is +ve.

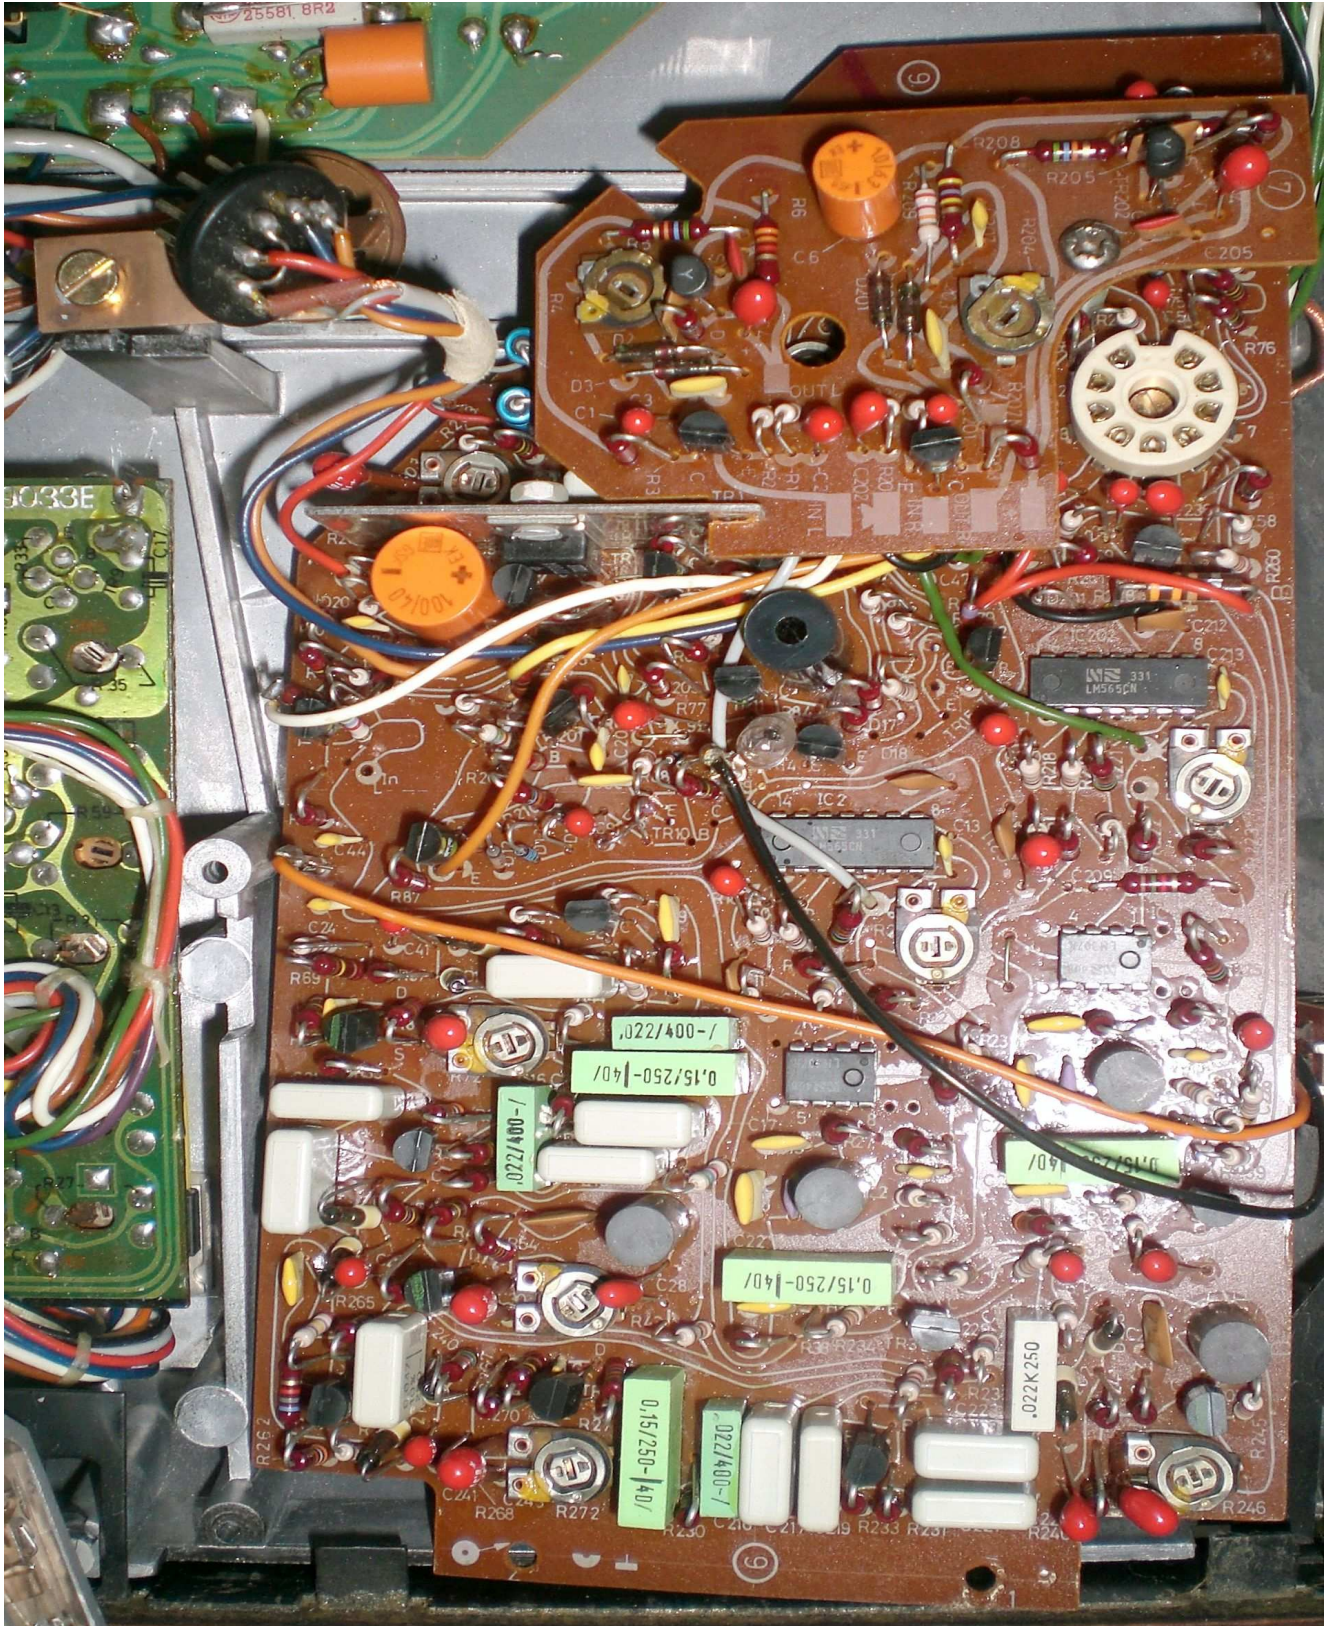
This is the RIAA PCB before Modification:

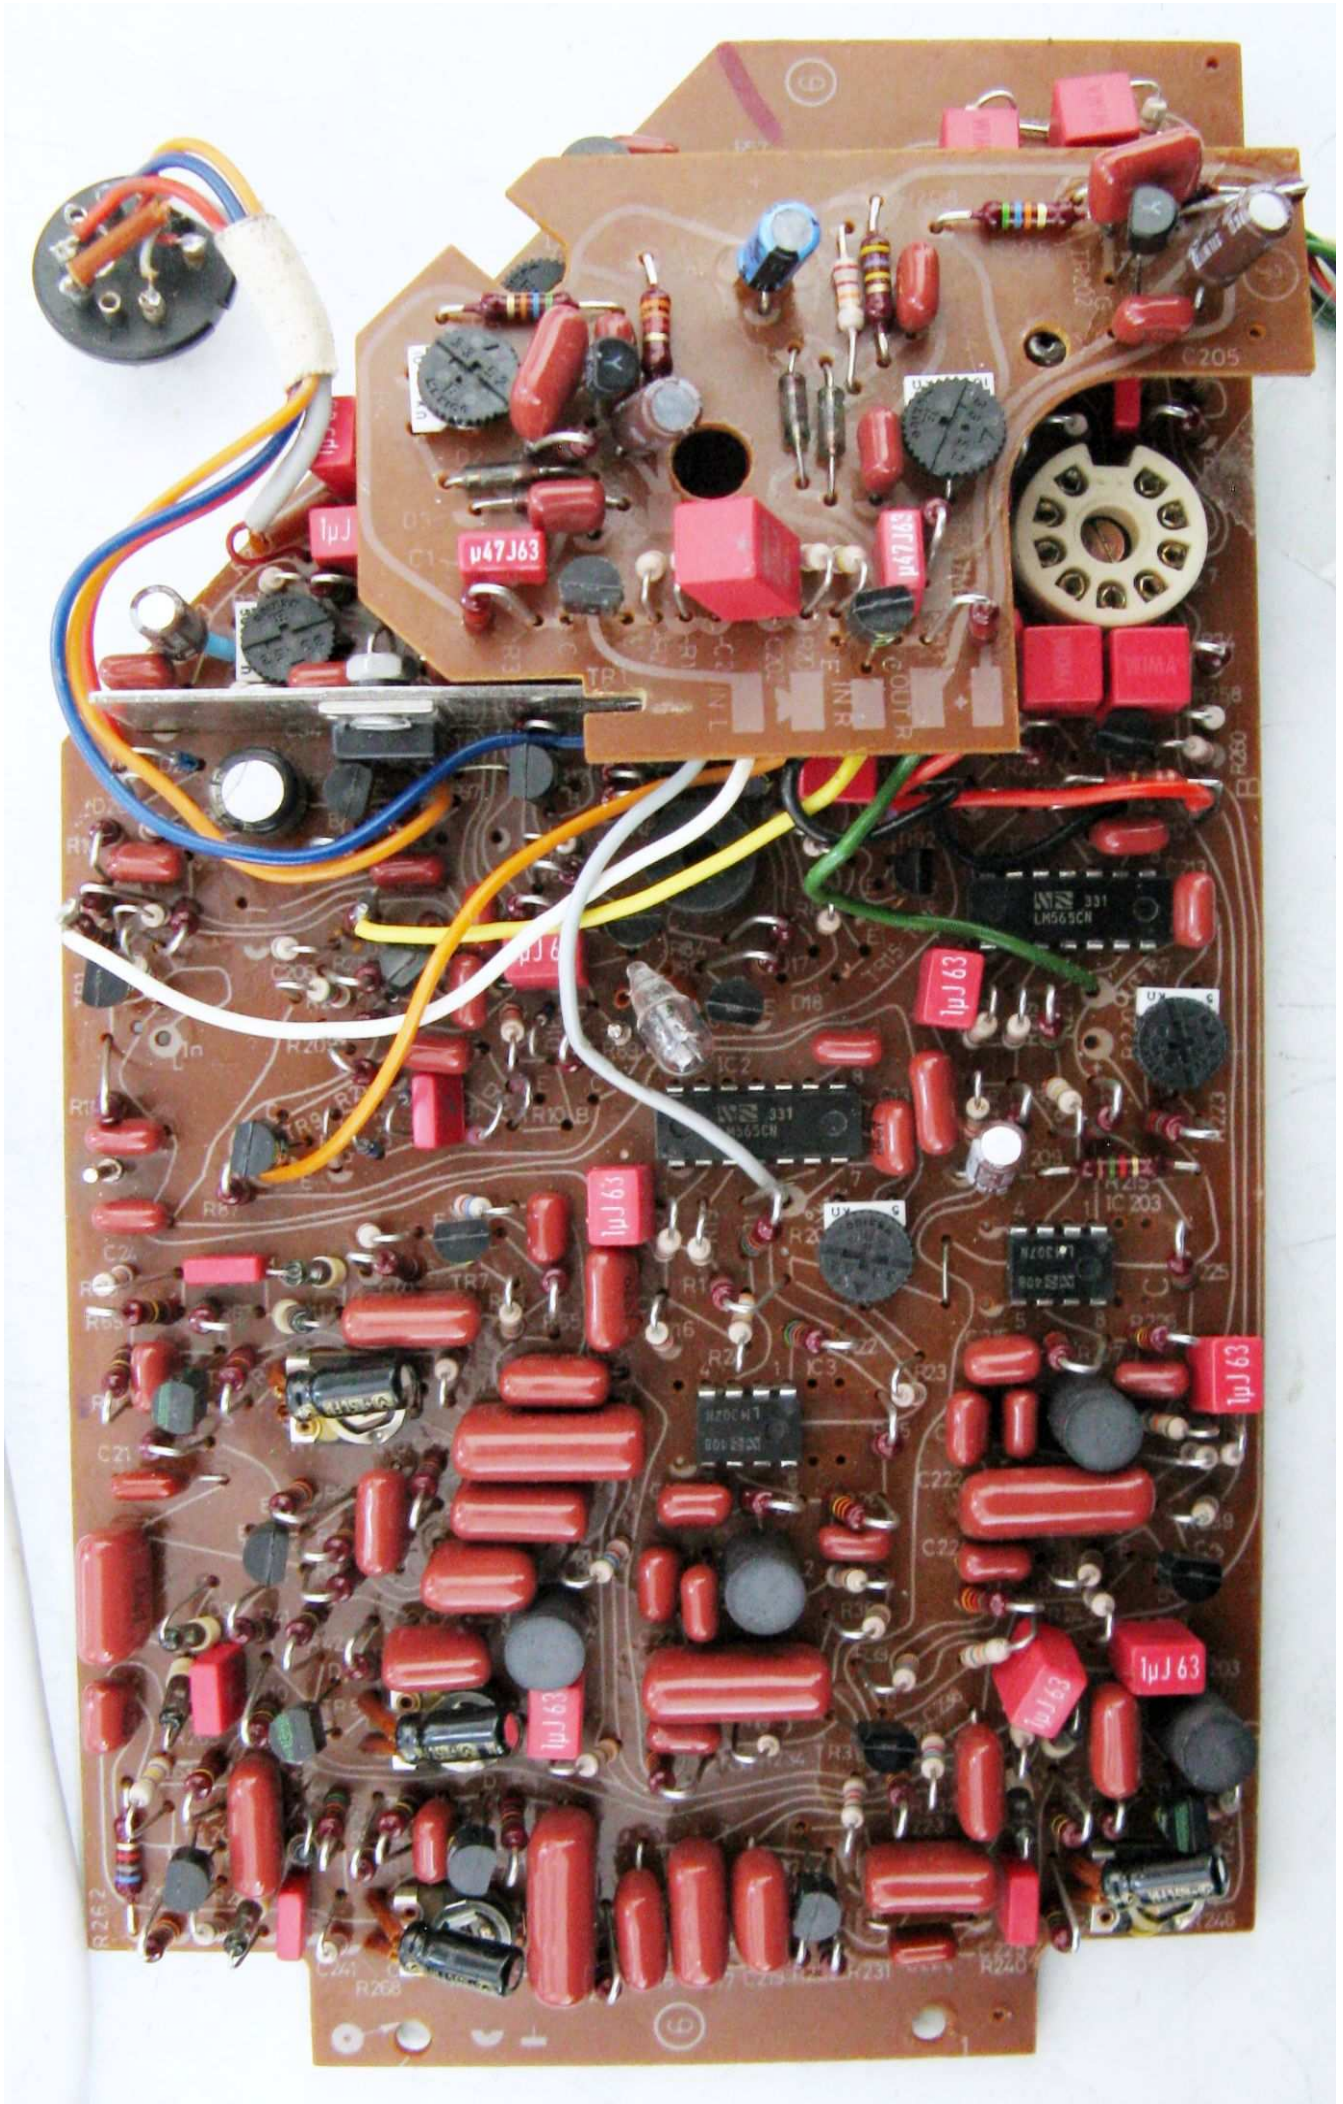
This is the RIAA PCB after Modification:

I replaced all the Electrolytic and Tantalum Caps with a nice blend of Panasonic FM and ECQP, Elna Silmic II, and Wima MKS2 caps, and the potentiometers with Bourns 3352 Cermet units.

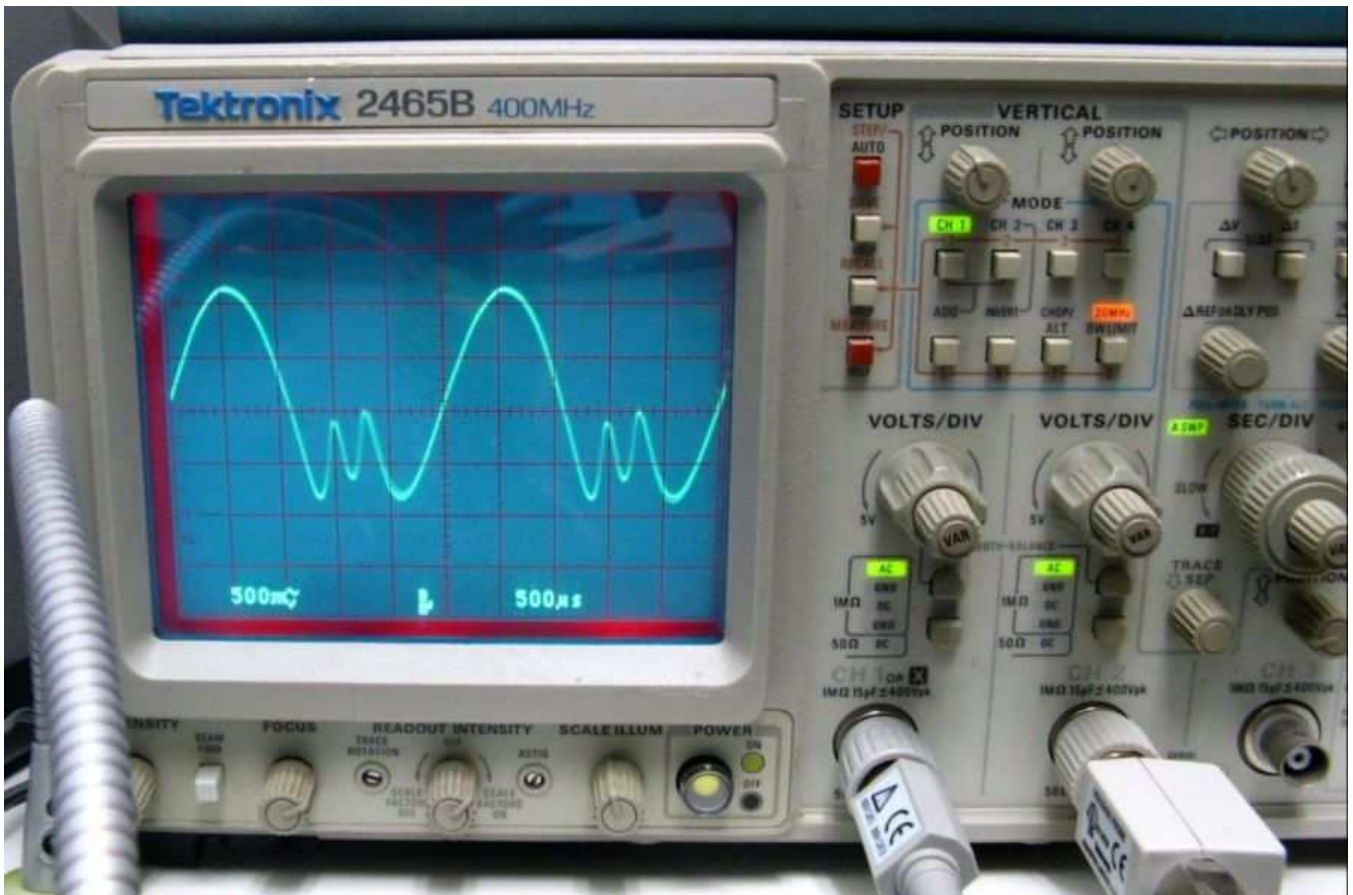
13. This shows the CD4 alignment signal on the RIAA amplifier adjusted according to the Service Manual.
