SOUND CONTROL IN BELL TOWERS - GUIDANCE NOTES

Towers & Belfries Committee - SOUND CONTROL IN BELLTOWERS

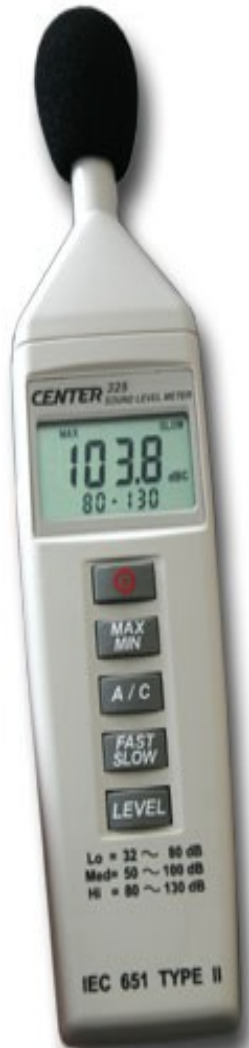
Measuring Sound Pressure Levels

- The human ear is most sensitive to sounds in the 500 Hz - 8 kHz range.
- Sound level meters incorporate electronic filtering to correspond with the varying sensitivity of the ear. This filtering is called A-weighting and measured sound pressure levels are signified as dB(A).
- There are two settings: the FAST setting attempts to catch peaks of sound whereas the SLOW setting averages sound levels over a longer time period.
- Ringers' perceptions of bell sound levels correlate well with use of dB(A) and a SLOW setting.
- Sound level meters are available at low cost (< £100).

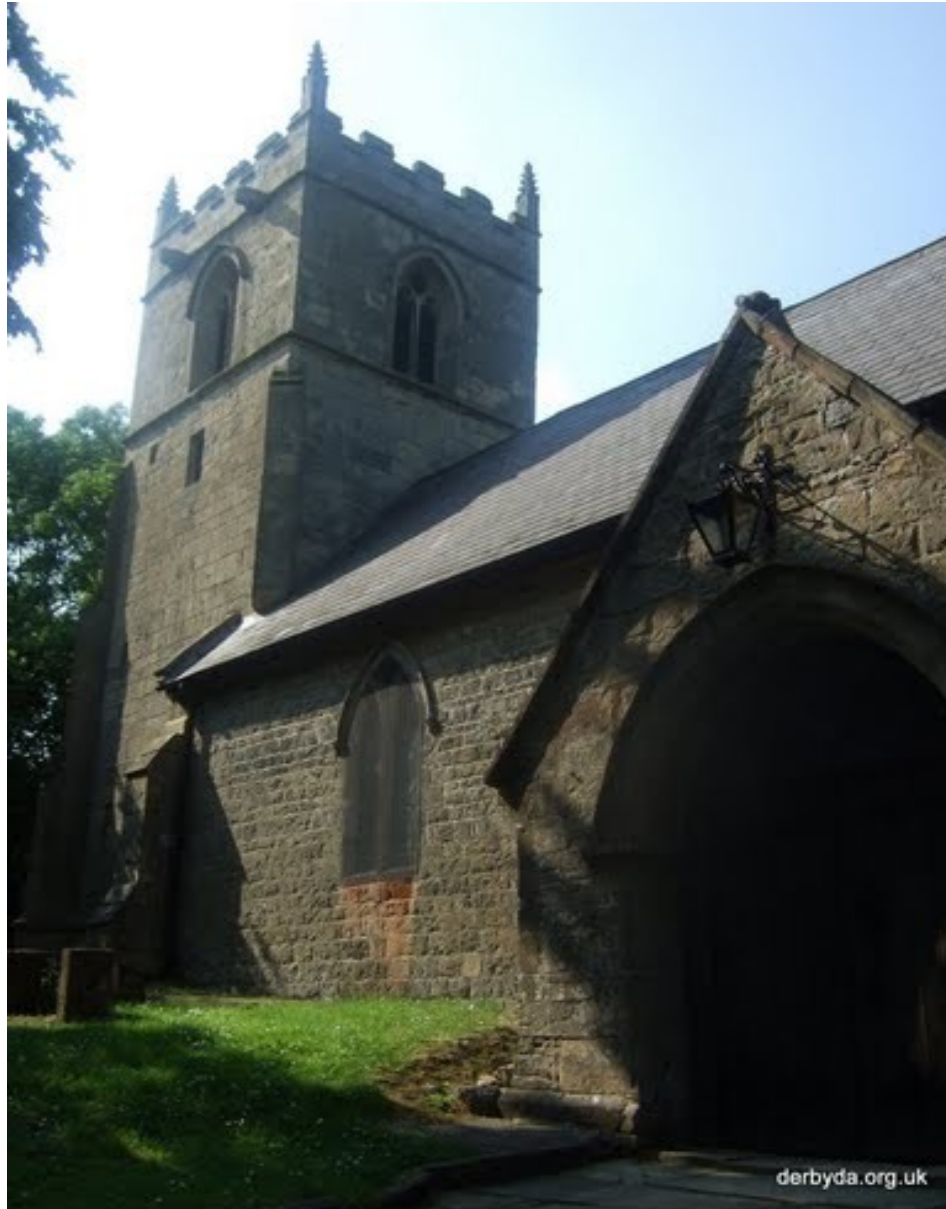
- In towers with up to 6 bells, the peak sound level of the tenor bell rung by itself is close to the average sound level with all bells ringing. This fact is useful in situations where there are few ringers available during lengthy sound reduction trials, as in the case studies.
- A minimum of two people is necessary for sound level measurements – one to ring each bell in turn and one to read and record the levels keeping a full log of all acoustic changes and their consequences.
- Consistent, repeatable ringing is essential. The ringer must be competent at bell handling and all ringing carried out by one person since different ringing styles produce slightly different sound levels.
- Sound level readings should be taken for both hand and backstroke.
- Ear protection is essential in the bell chamber.
- Hold the sound level meter away from the body.

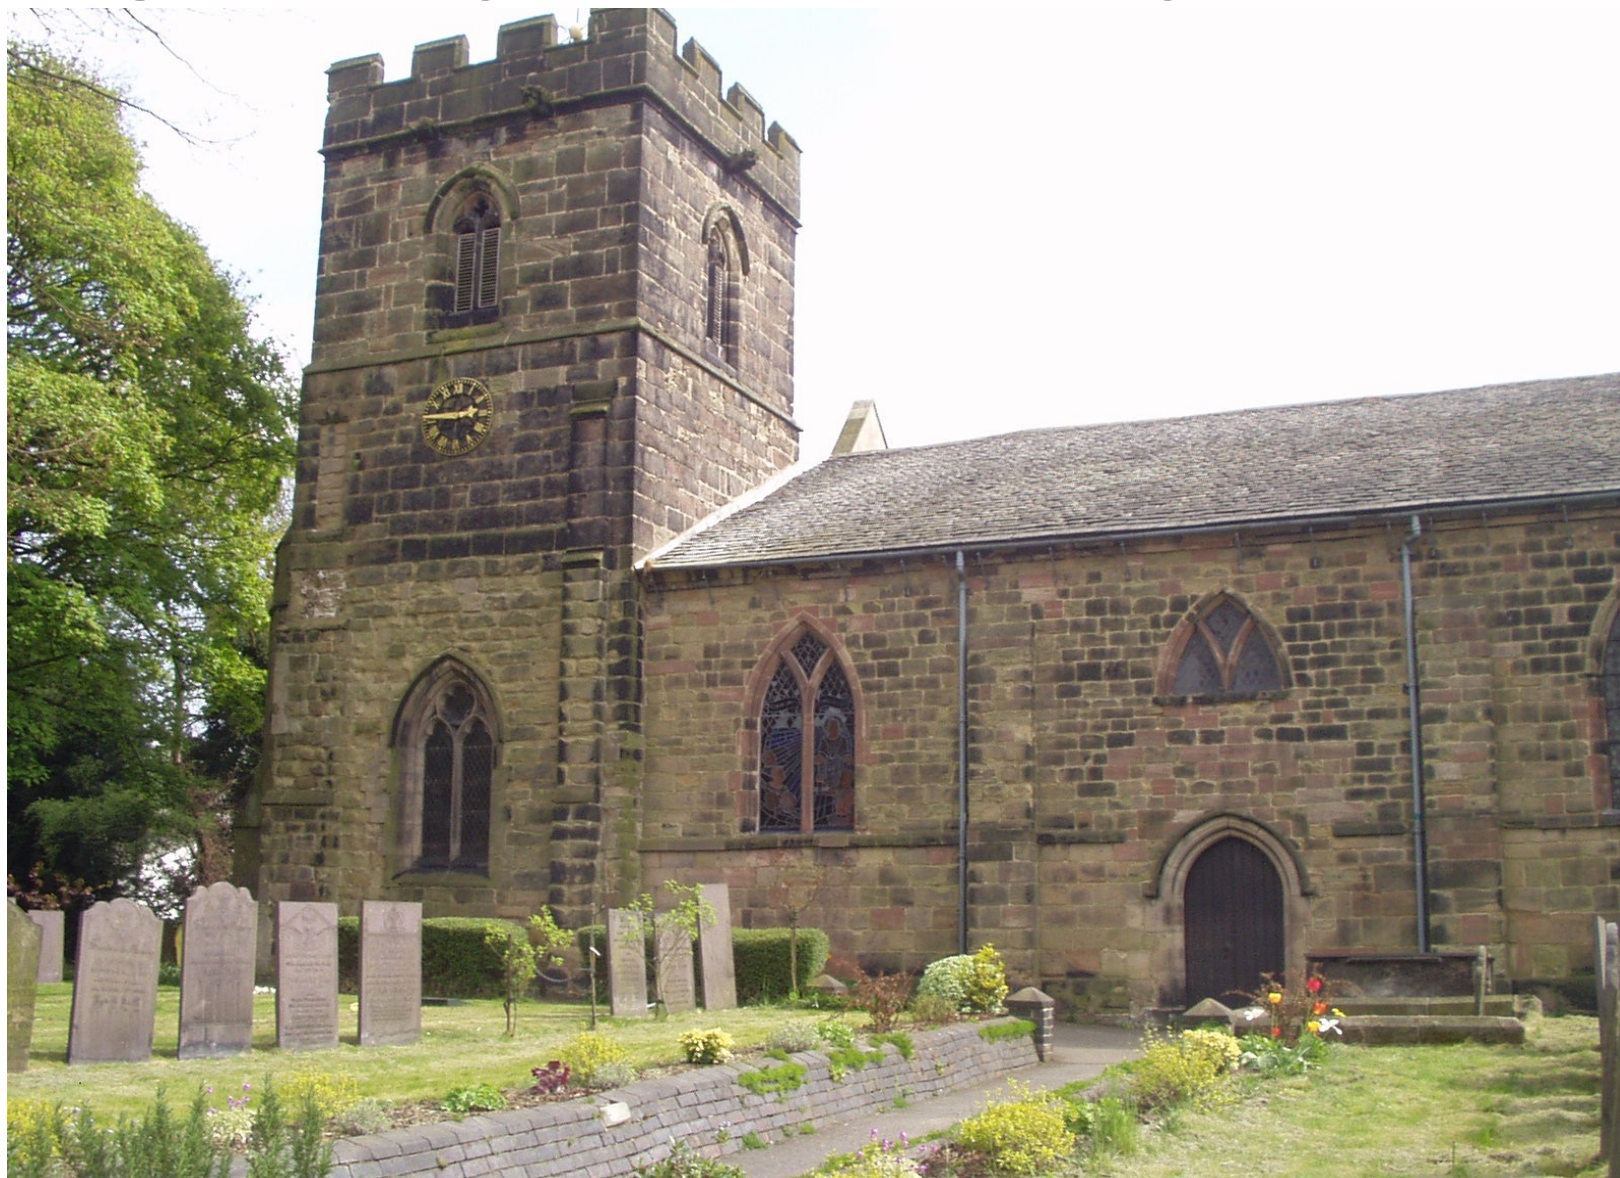
Ss George & Mary, Church Gresley Case Study (2)

Case Study (2) – Church Gresley, Derbyshire

| Ringling Room as found | 87 dB(A) |
| Attenuation as found | 24 dB(A) |

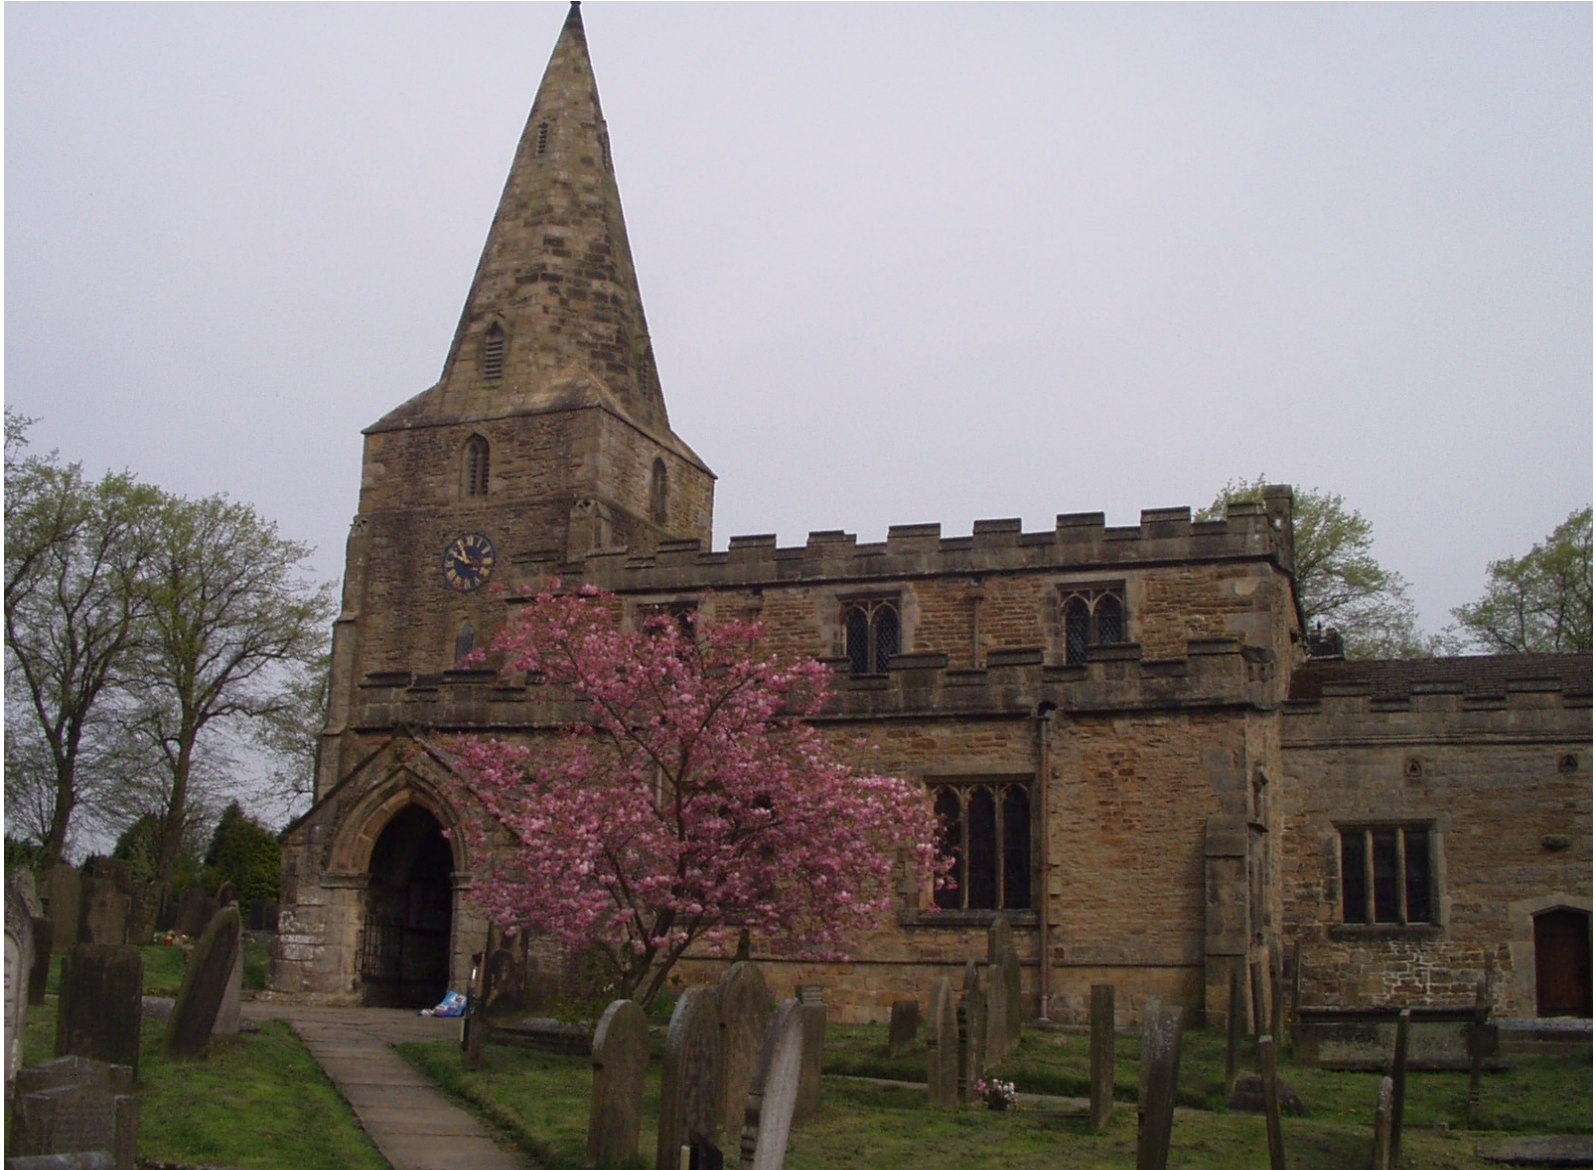
Ss Peter & Paul, Old Brompton Case Study (3)

Case Study (3) – Old Brampton, Derbyshire

- **Problem** – sound levels in ringing room too high (five bells at or above 80 dB(A)) and sound barrier in poor structural condition.
- **Number of bells:** 6
- **Tenor weight:** 12-0-9
- **Draught:** short
- **Sound barrier:** single composite type 1, no rope-hole tubes.
- **Sources of flanking sound:**
 - gaps between barrier and walls
 - gaps around edge of access trap door
 - unsealed clock weight chutes
 - low mass / unit area trap door construction.

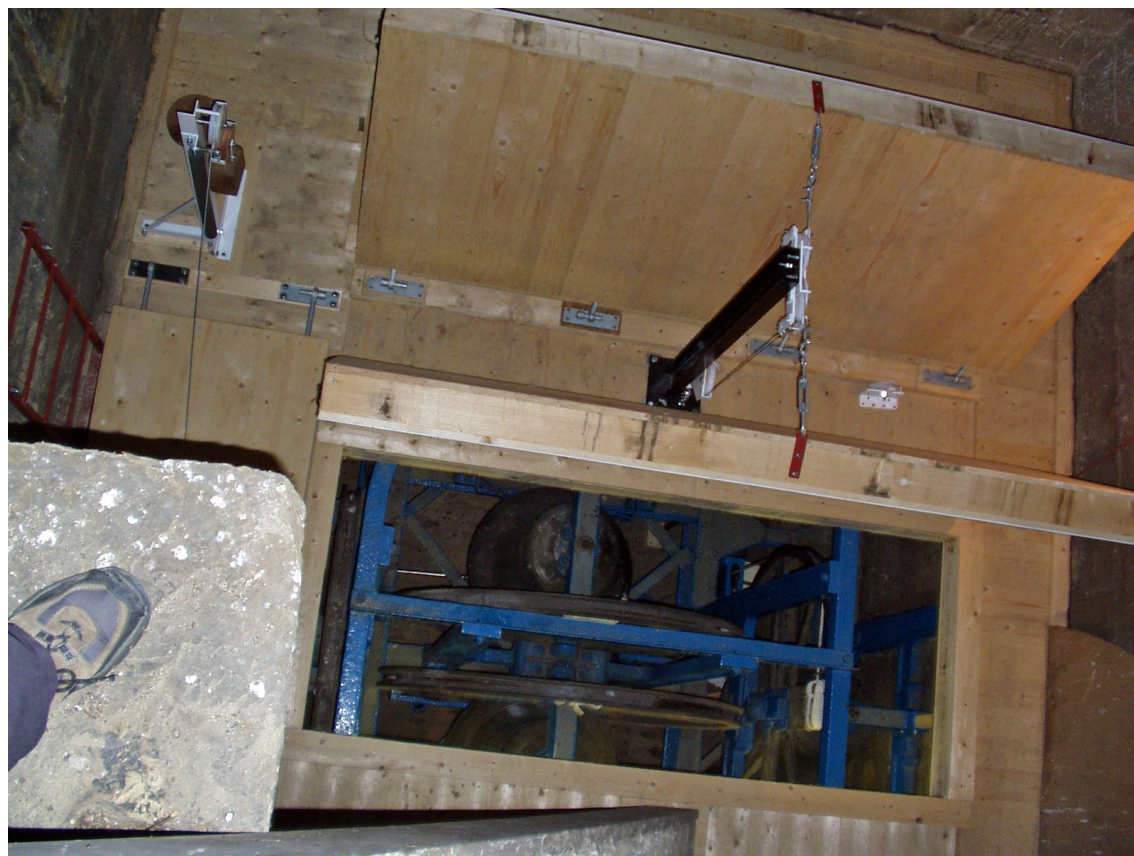
Horizontal Variable Sound Control

Partial Sound Barrier and its Sound Shadow

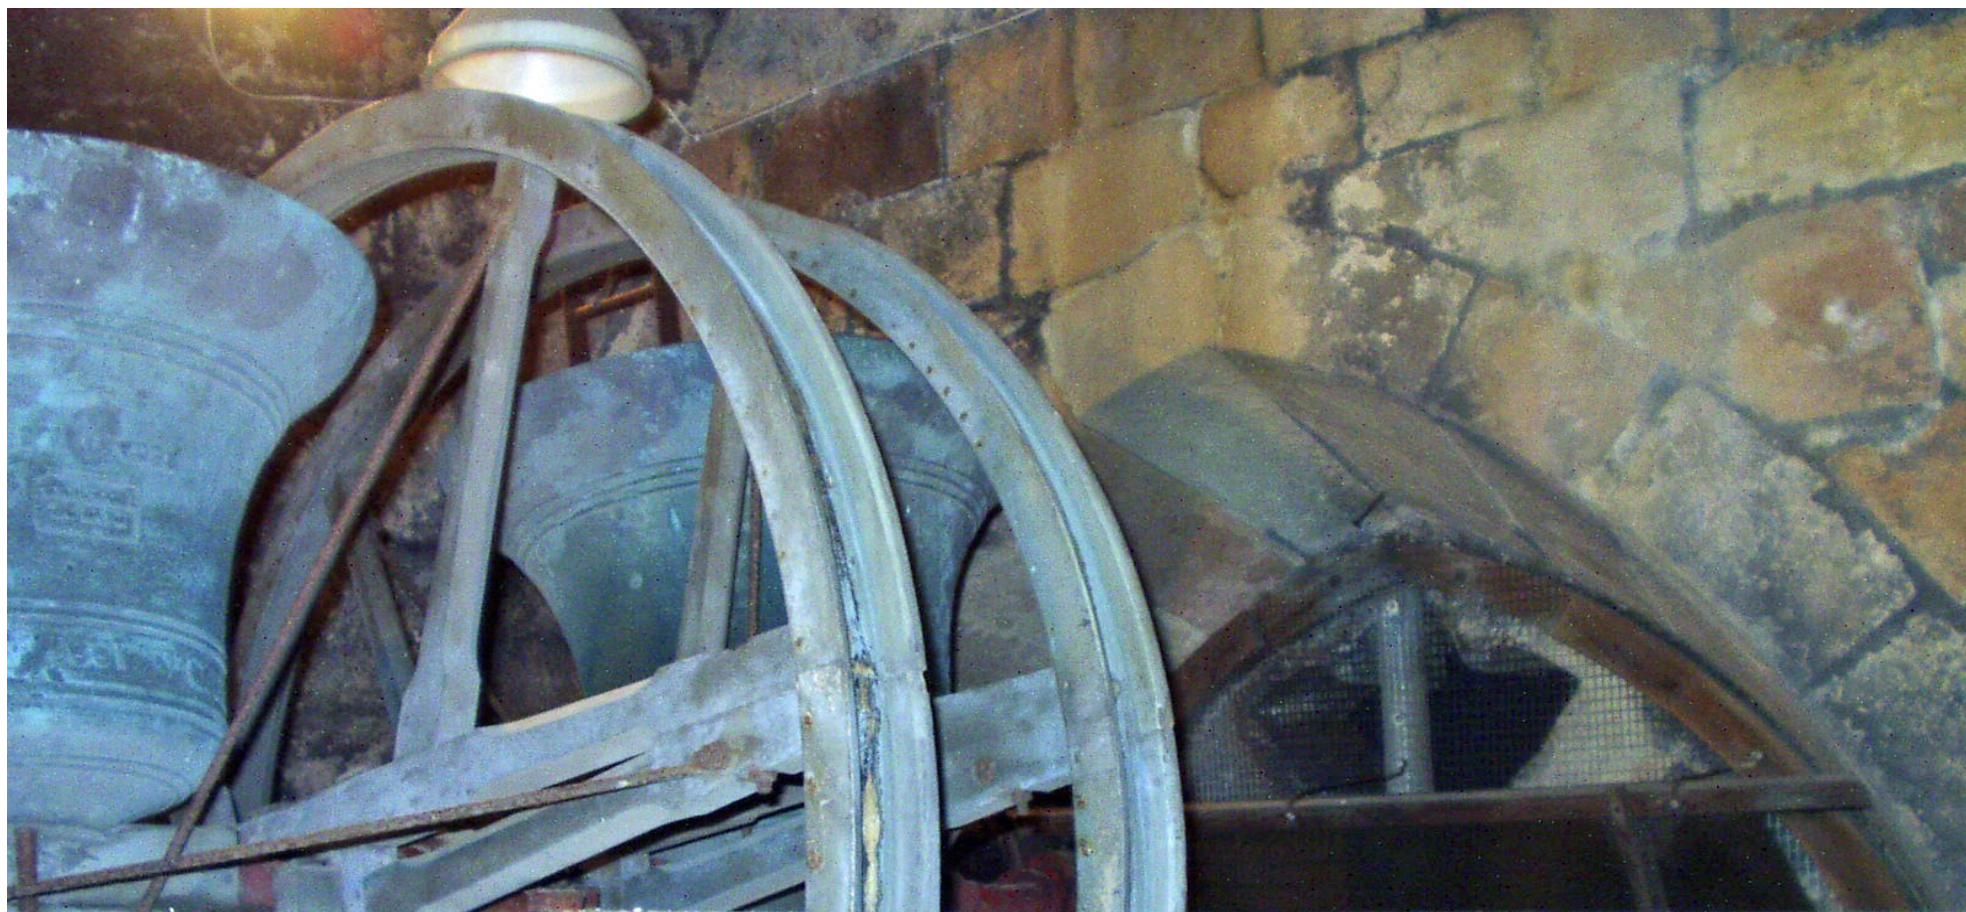
External Sound Control – Bells that Shout

Control of Sound Levels Outside the Tower - Sound Lantern Reducing Local Sound Levels

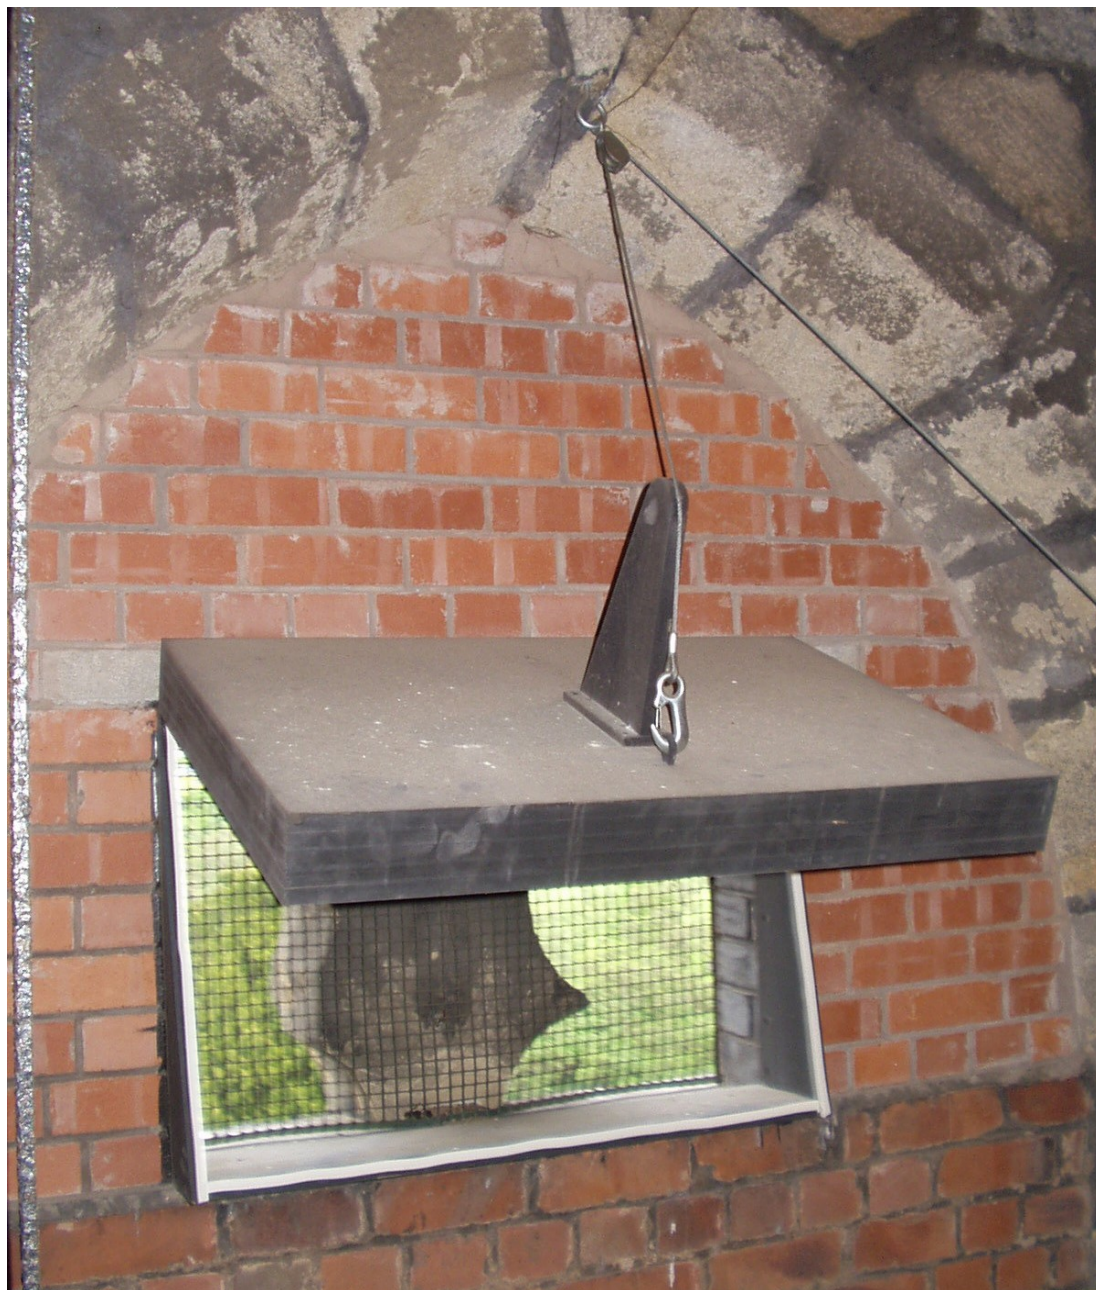
**Variable
Sound
Control
- Duffield**

- **Problem** – external sound levels for residents on Duffield Bank to the east, and in church hall to the south of the tower intrusive when peals rung.
- **Number of bells:** 10
- **Tenor weight:** 17-2-11
- **Tower configuration** - stone spire surmounting substantially built stone tower with one sound window to each of the four aspects. No spire openings other than ventilation opening at base of west side.
- **Remedial work** – brick sound barriers, incorporating gravity-closing sound control doors, fitted to south and east sound windows only. Each door opening size 860 X 570 mm.
